[www.cityofvallejo.net](http://www.cityofvallejo.net)

### VALLEJO ARCHITECTURAL HERITAGE AND LANDMARKS COMMISSION REGULAR MEETING – 6:30 P.M. CITY COUNCIL CHAMBERS September 21, 2023

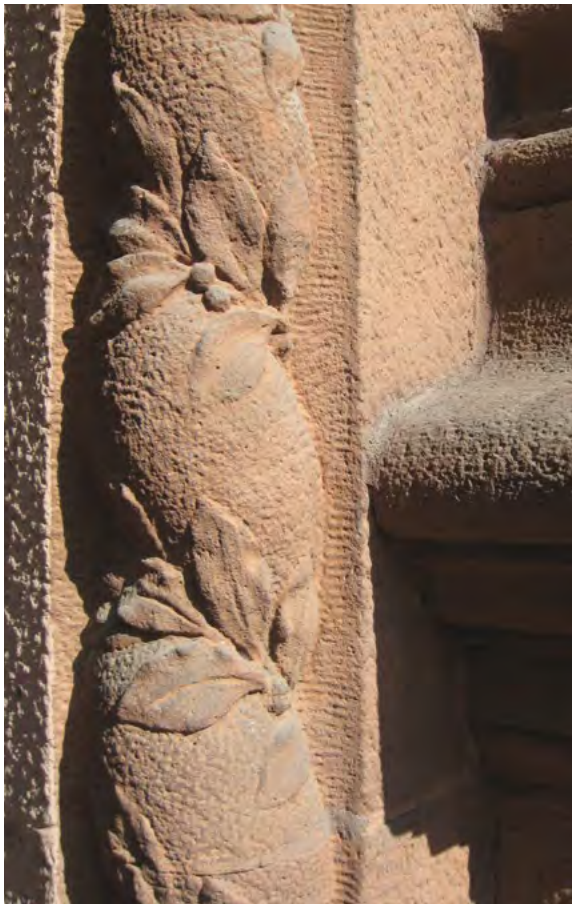
While masonry is one of the most durable historic building materials, it is also very susceptible to damage by exposure, improper maintenance or repairs, abrasive cleaning, or the application of non-permeable coatings.

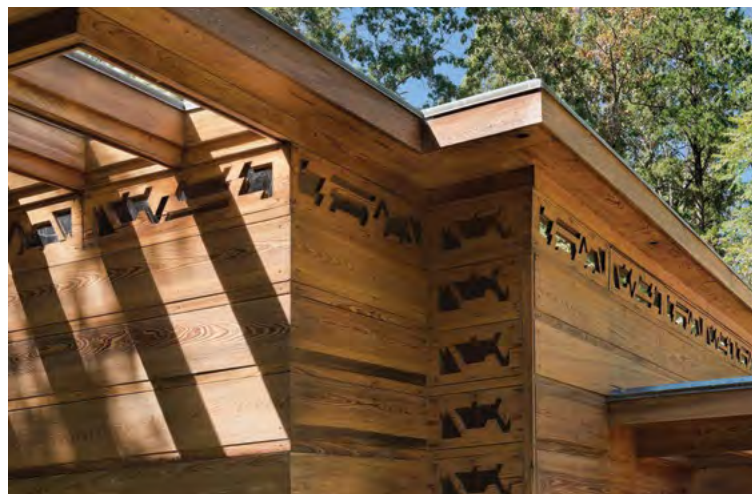
Many historic buildings have wood structural systems and features, such as stairs or columns. The majority of both practical and decorative features, particularly on the interior, are made of wood, such as flooring and paneling.

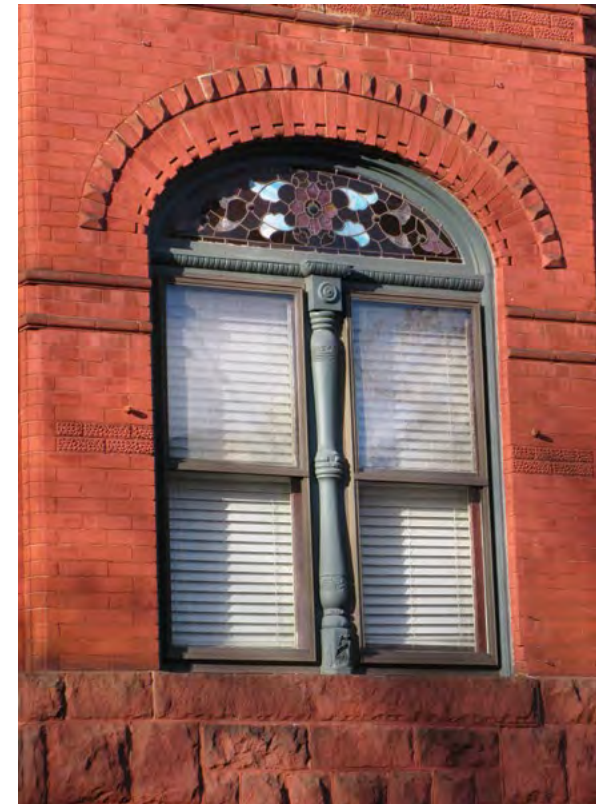
## Entrances and Porches

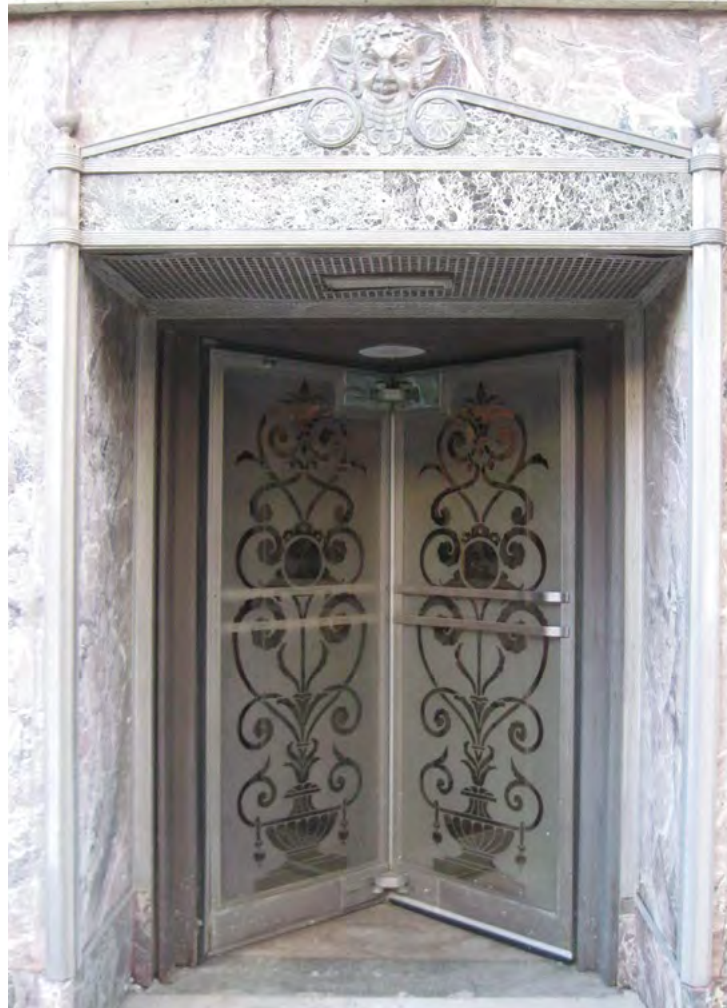
ally, entrances and porches were integral components of a historic building's design; for example, porches on Greek Revival houses, with pediments and Doric or Ionic columns, echoed the architectural elements and features of the building itself. Center, single-bay porches or arcaded porches are evident in Italianate-style buildings of the 1860s. Doors of Renaissance Revival-style buildings frequently featured entablatures or pediments. Porches characterized by lathe-turned porch posts, railings, and balusters were especially prominent and decorative features of Eastlake, Queen Anne, and Stick-style houses. Deep porches on bungalows and Craftsman-style houses of the early 20th century feature tapered posts, exposed posts and beams, rafter tails, and low-pitched roofs with wide overhangs.

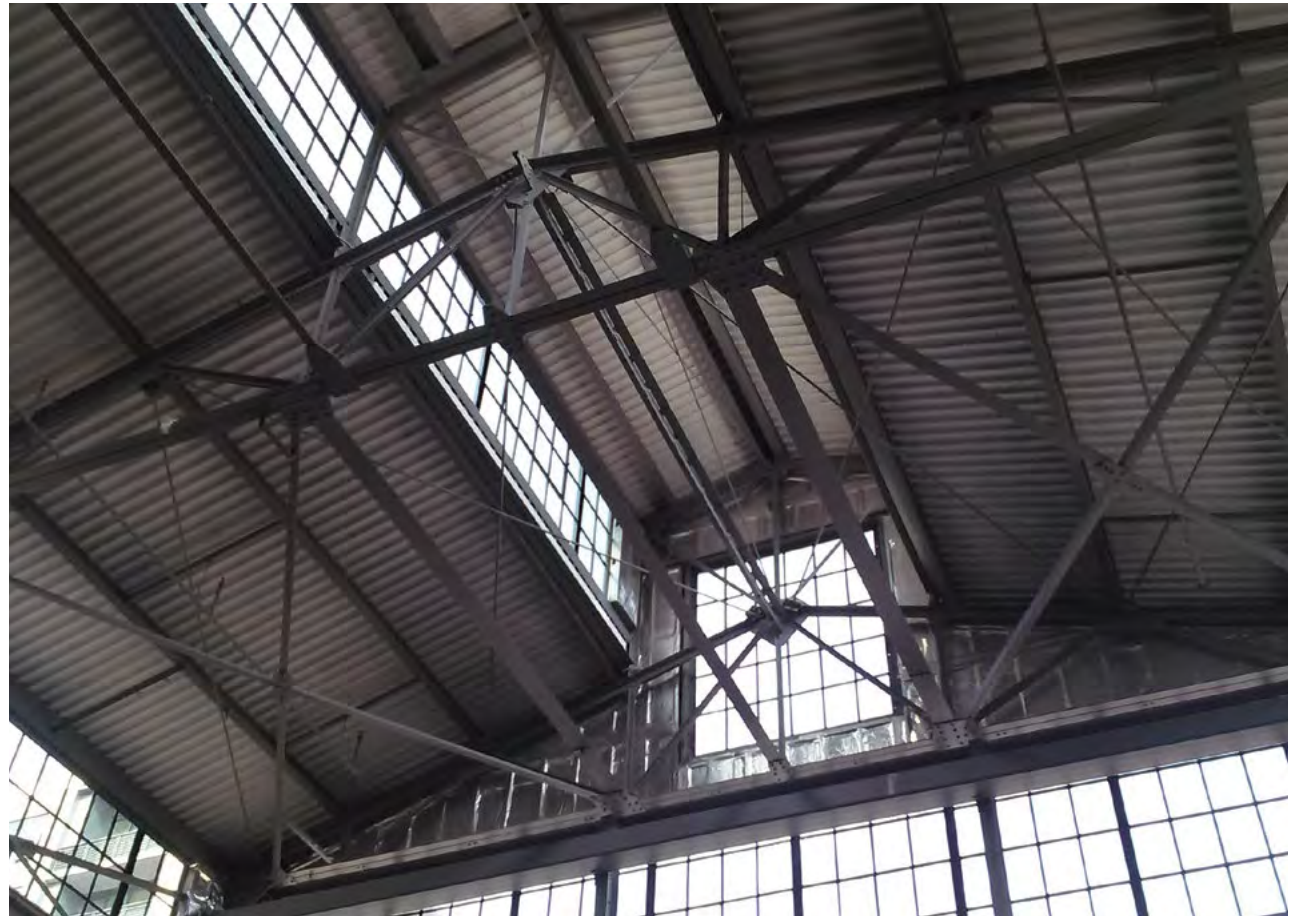
beams, vigas, and outriggers, or masonry foundation walls), they are likely to be important in defining the building's overall historic character. A concealed structural system, although not character defining, may still be significant as an example of historic building technology.

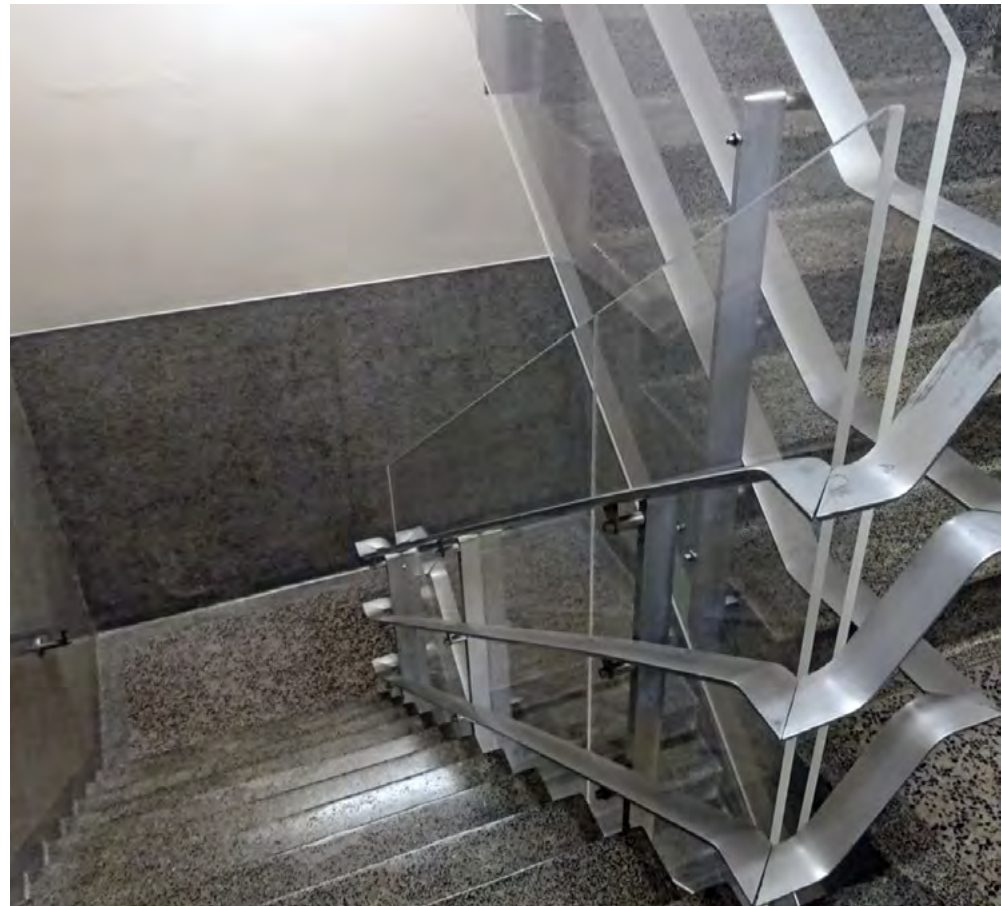
## Resilience to Natural Hazards

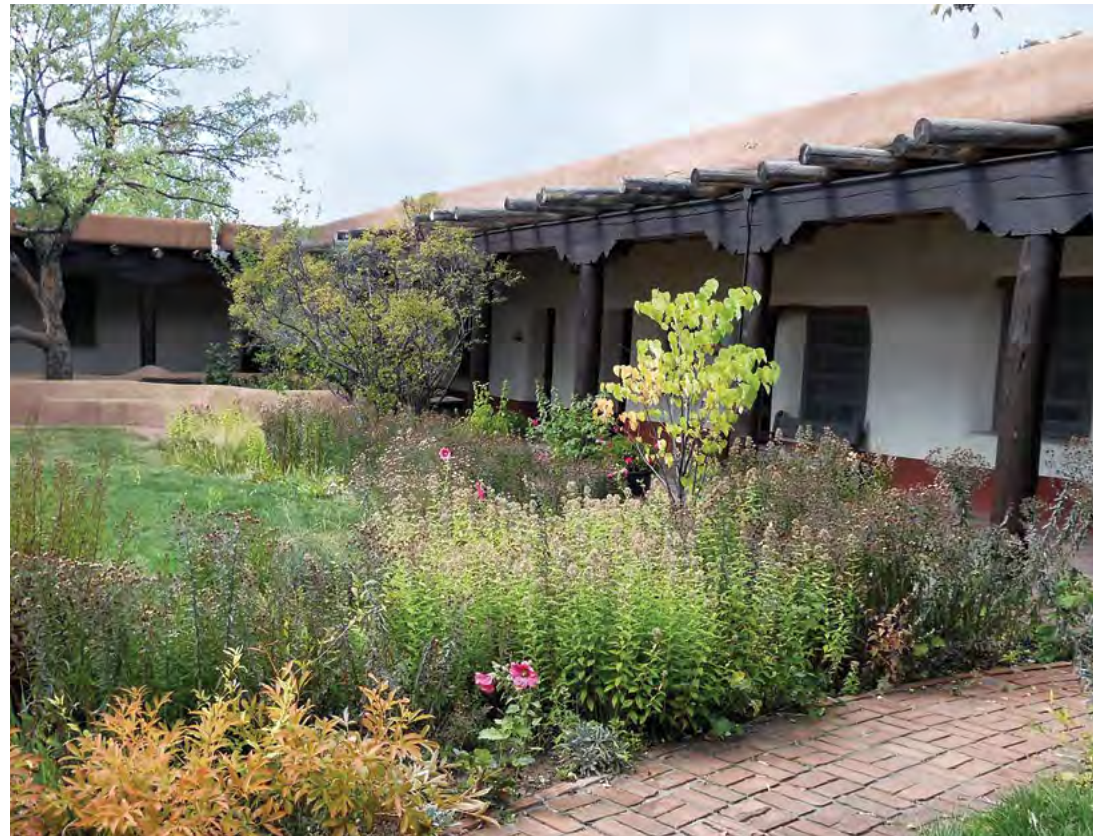
### Standards for Preservation

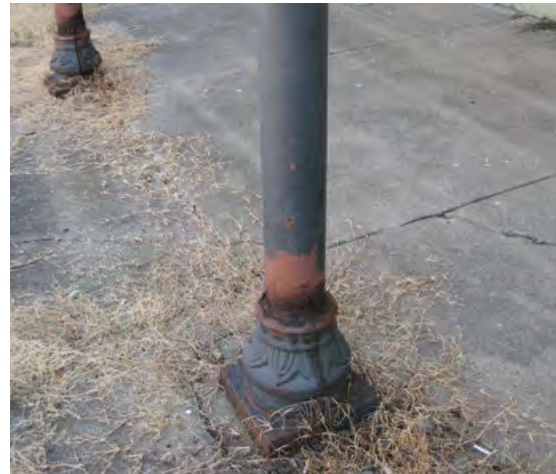
[7] (a) After the damaged portions of the base were repaired, (b) the cast-iron columns were cleaned and repainted to protect the metal from rusting.

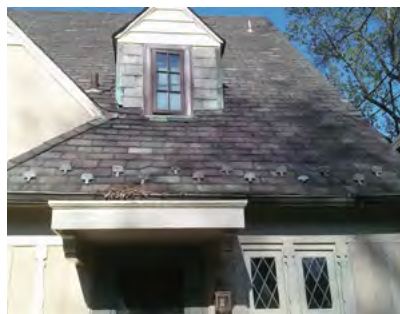
[8] Regular maintenance includes removing leaves that can clog gutters and cause water damage to the exterior and interior walls of a house.

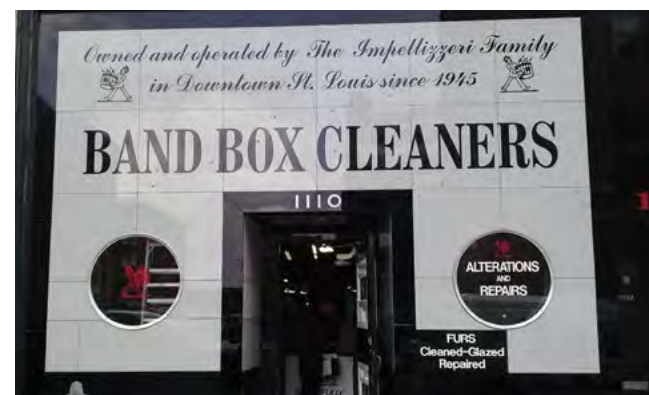
[14] The signage is an original and integral part of this historic Carrara glass storefront.

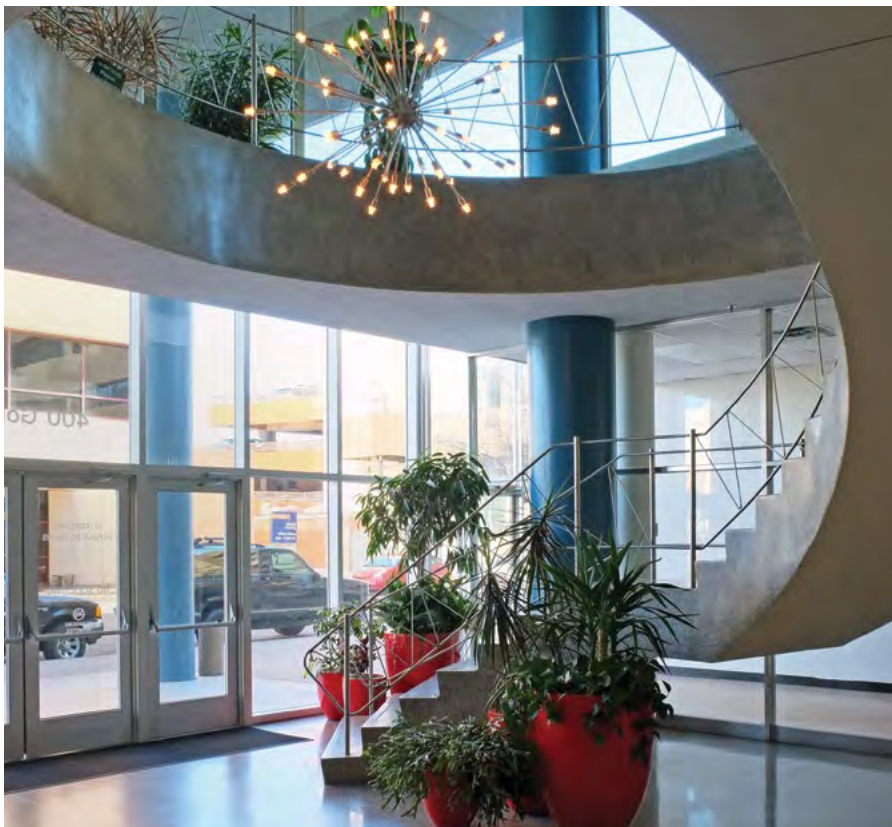
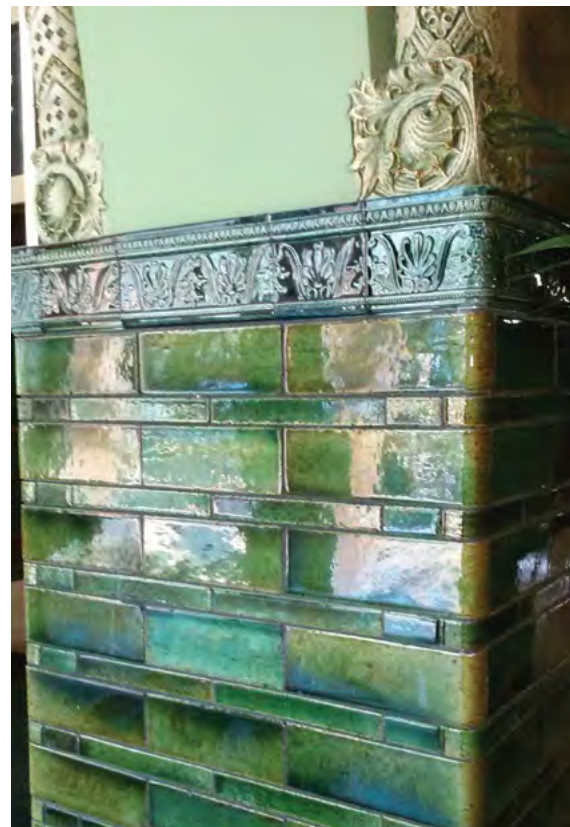
[19] The sweeping staircase with its metal railing, chandelier, and terrazzo floor in the lobby of the 1954 Simms Building, Albuquerque, NM, are character-defining features. *Photo: Harvey M. Kaplan.*

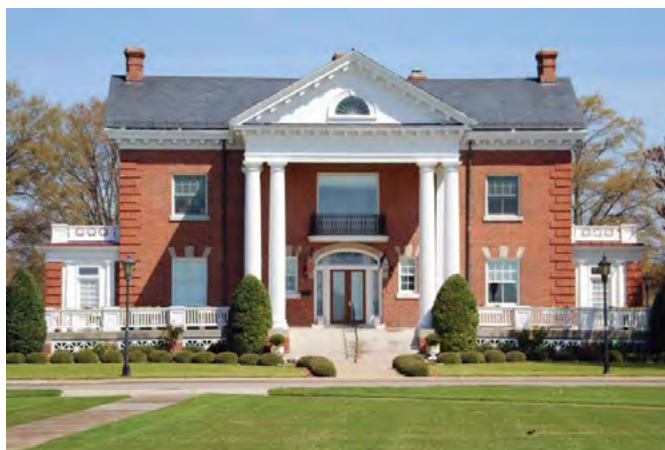
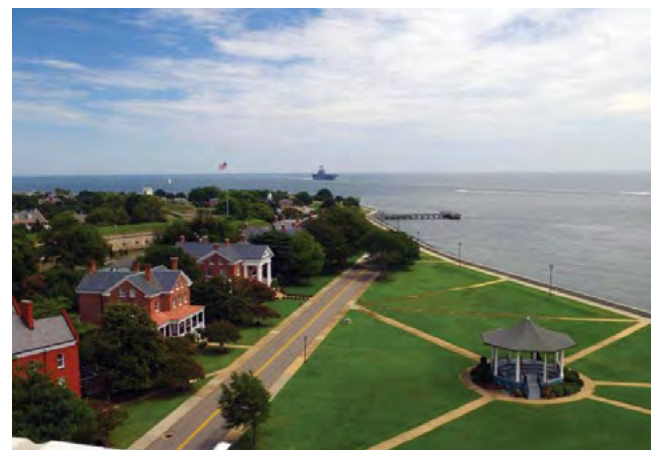
SETTING (DISTRICT / NEIGHBORHOOD)

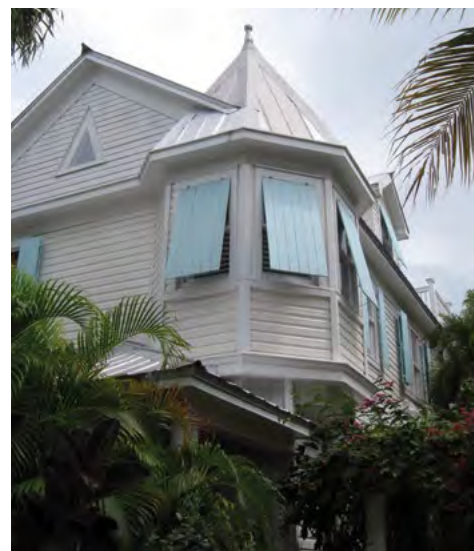
[30] Historic window shutters still serve their original function as protection in hurricane-prone areas.

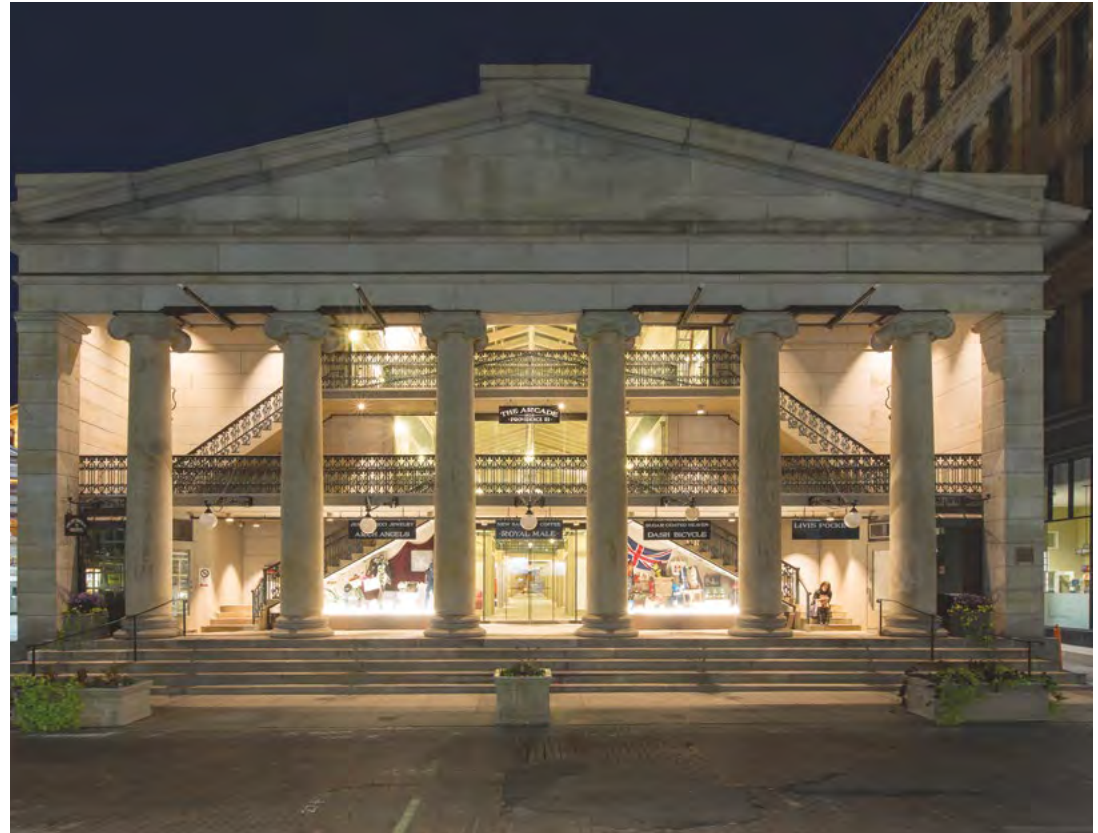
## Standards for Rehabilitation

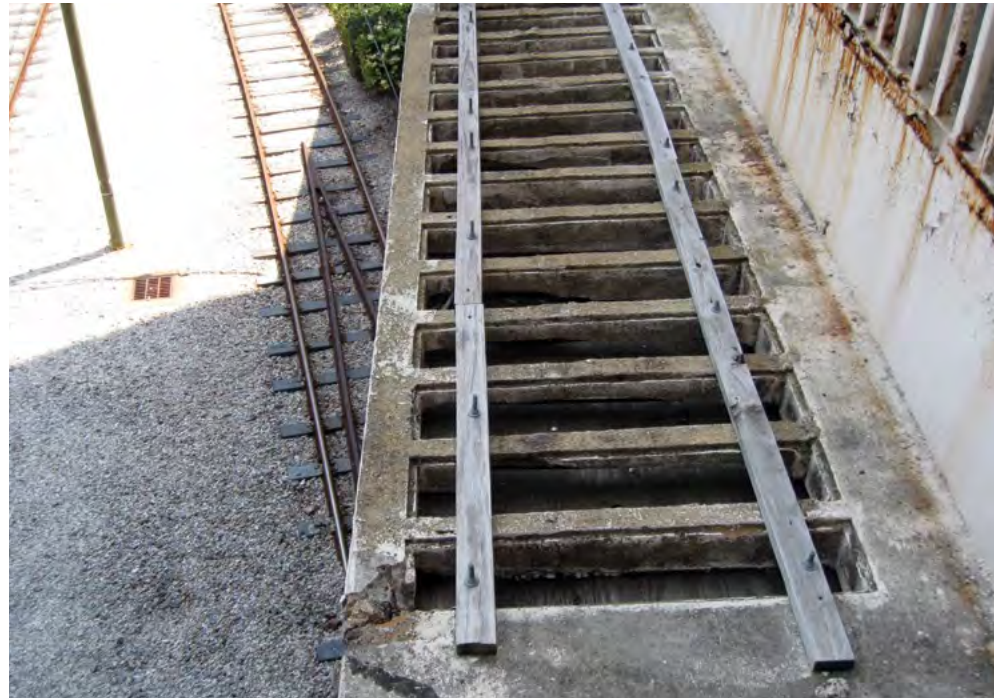
[6] Some areas of the concrete brise soleil screen on this building constructed in 1967 are badly deteriorated. If the screen cannot be repaired, it may be replaced in kind or with a composite substitute material with the same appearance as the concrete.

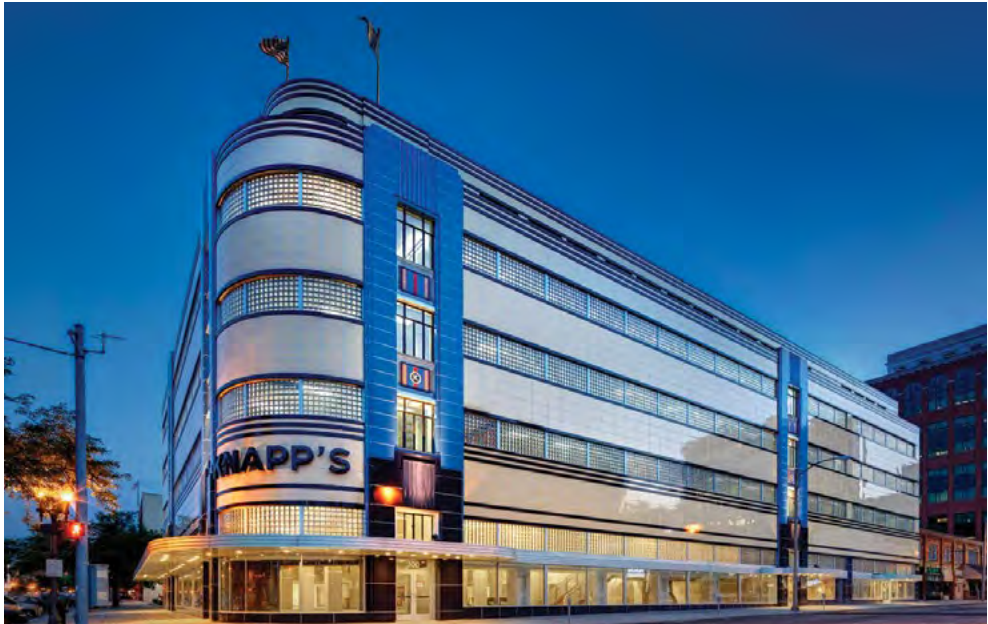
## MASONRY: STONE, BRICK, TERRA COTTA, CONCRETE, ADOBE, STUCCO, AND MORTAR

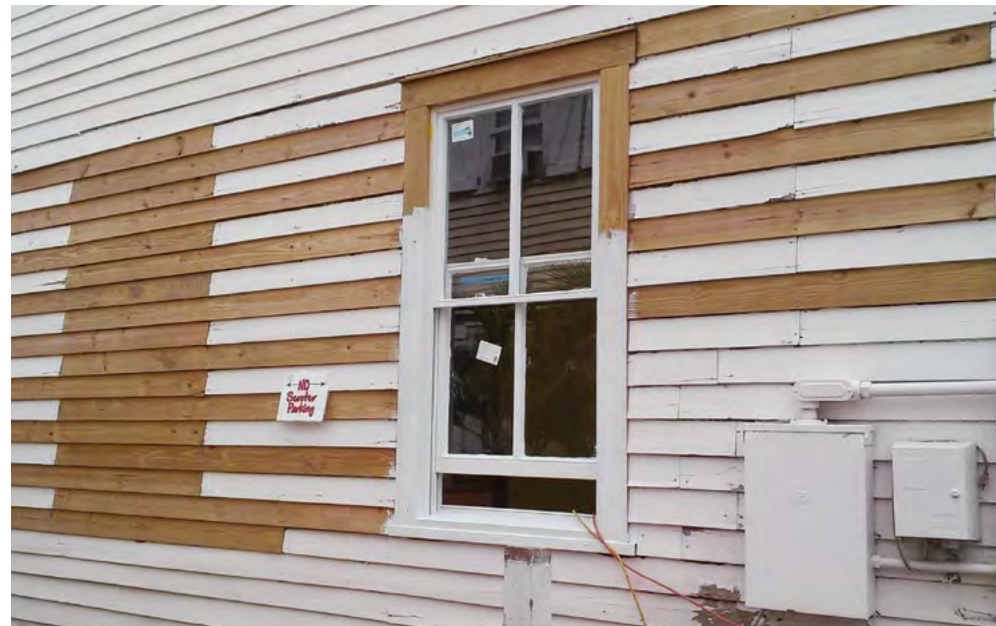
## WOOD: CLAPBOARD, WEATHERBOARD, SHINGLES, AND OTHER FUNCTIONAL AND DECORATIVE ELEMENTS

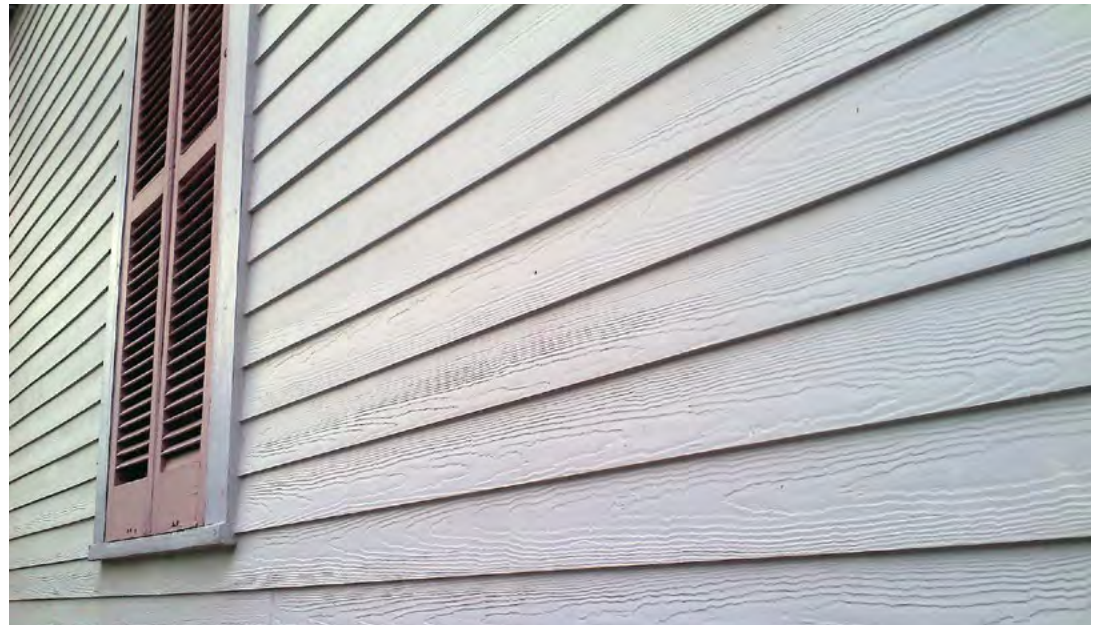
## WOOD: CLAPBOARD, WEATHERBOARD, SHINGLES, AND OTHER FUNCTIONAL AND DECORATIVE ELEMENTS

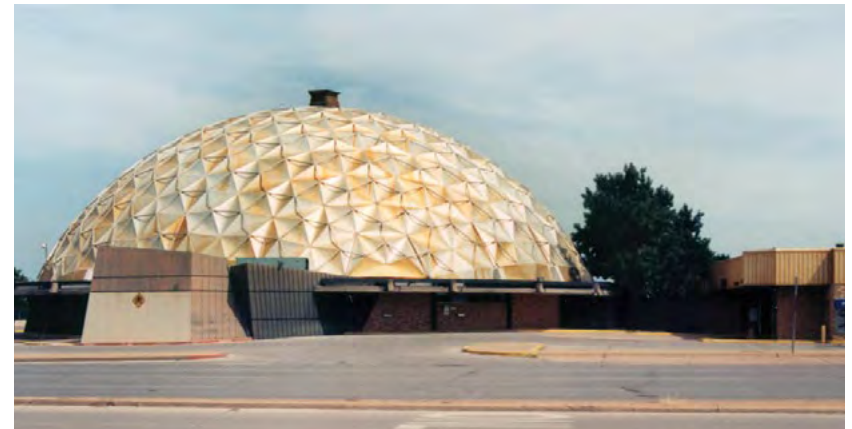
[13] The gold-colored, anodized aluminum geodesic dome of the former Citizen's State Bank in Oklahoma City, OK, built in 1958 and designed by Robert Roloff, makes this a distinctive mid-20th century building.

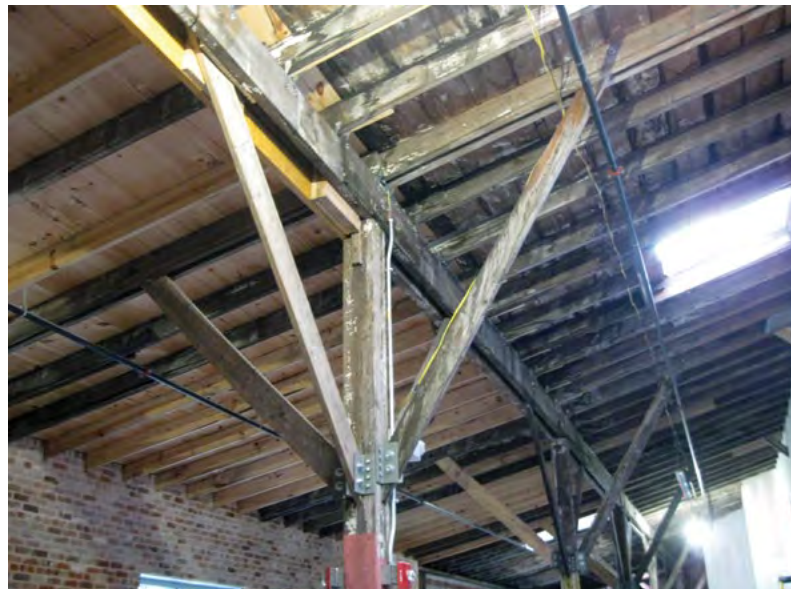
[17] New wood elements have been used selectively to replace rotted wood on the underside of the roof in this historic warehouse.

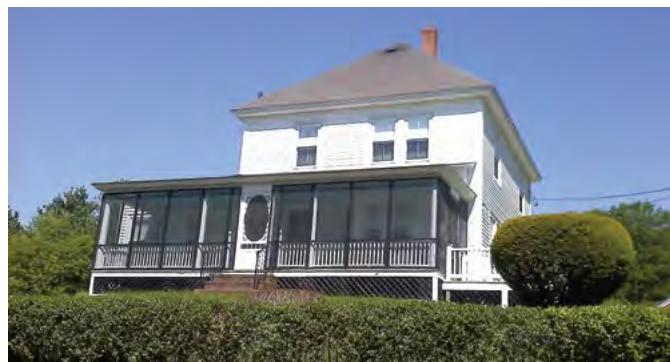
[26] **Not Recommended:** Installing a screened enclosure is never recommended on a front or otherwise prominent historic porch. In limited instances, it may be possible to add screening on a porch at the rear or on a secondary façade; however, the enclosure should match the color of the porch and be placed behind columns and railings so that it does not obscure these features.

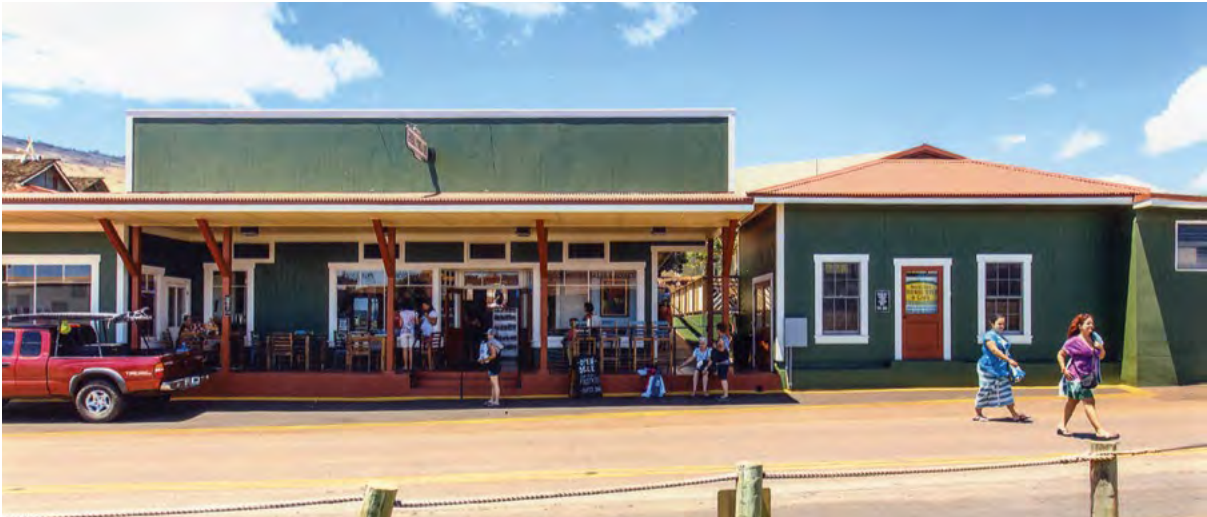
[29] The rehabilitation of the 1910 Māālaea General Store (a), which served the workers' camp at the Wailuku Sugar Company on the Hawaiian island of Maui, included the reconstruction of the original parapet (b).

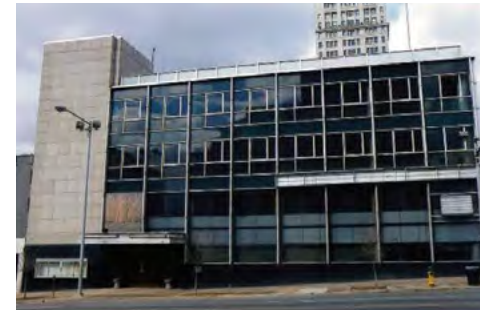
[31 a-c:] (a) The rehabilitation of the First Federal Savings and Loan Association building in Birmingham, AL, constructed in 1961, required replacing the deteriorated historic curtain wall system because the framing and the fasteners holding the spandrel glass and the windows had failed. (b) Comparative drawings show that the differences between the replacement system, which incorporated new insulated glass to meet wind-load requirements, and the original system are minimal. (c) The replacement system, shown after completion of the project, has not altered the historic character of the building.

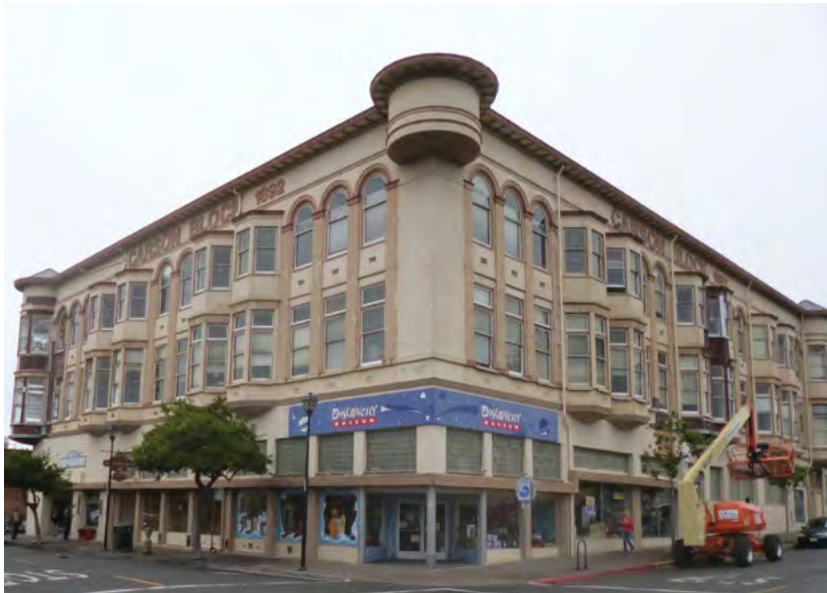
[32] (a-b) The rehabilitation of the 1892 Carson Block Building in Eureka, CA, for its owner, the Northern California Indian Development Council, included recreating the missing corner turret and sensitively introducing seismic reinforcement (c) shown here (opposite page) in a secondary upper floor office space. Photos: Page & Turnbull.

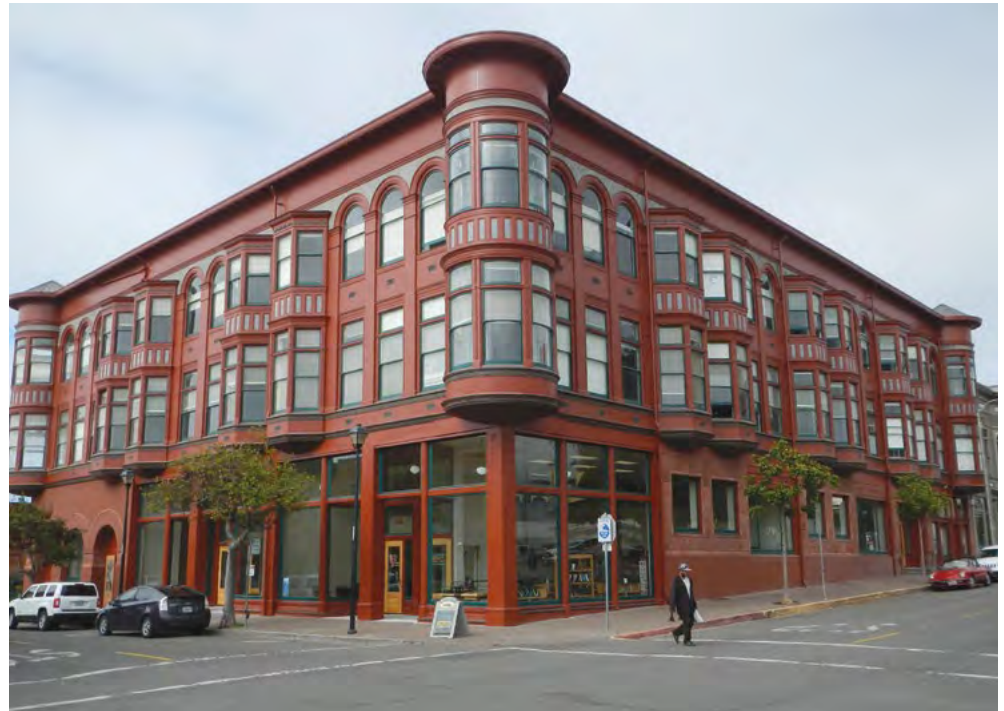
## STRUCTURAL SYSTEMS

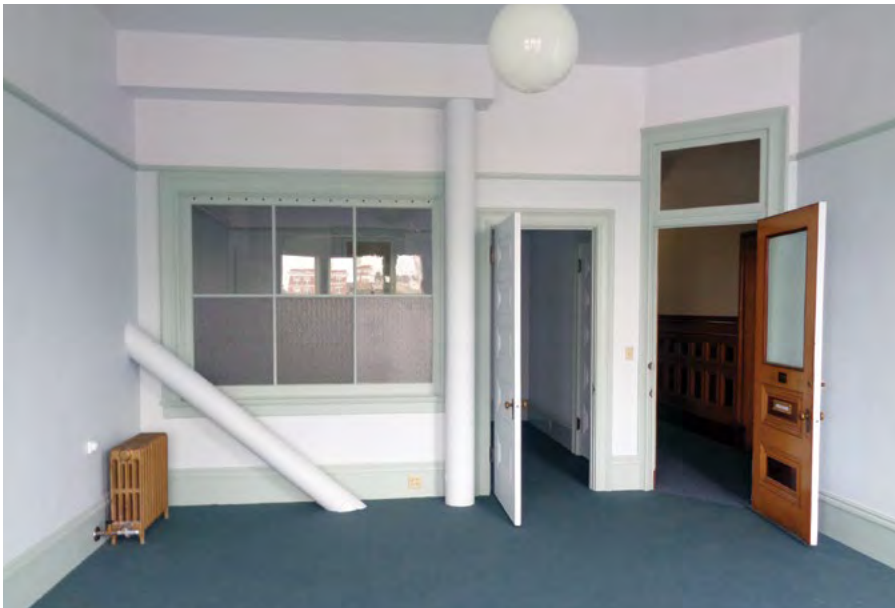
## STRUCTURAL SYSTEMS

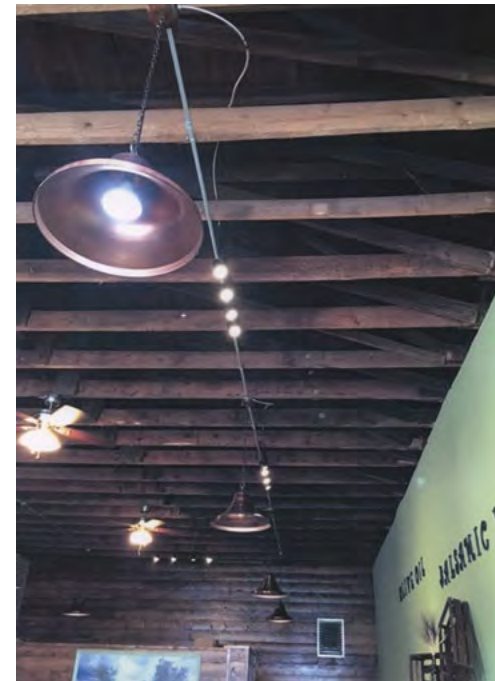
## INTERIOR SPACES, FEATURES, AND FINISHES

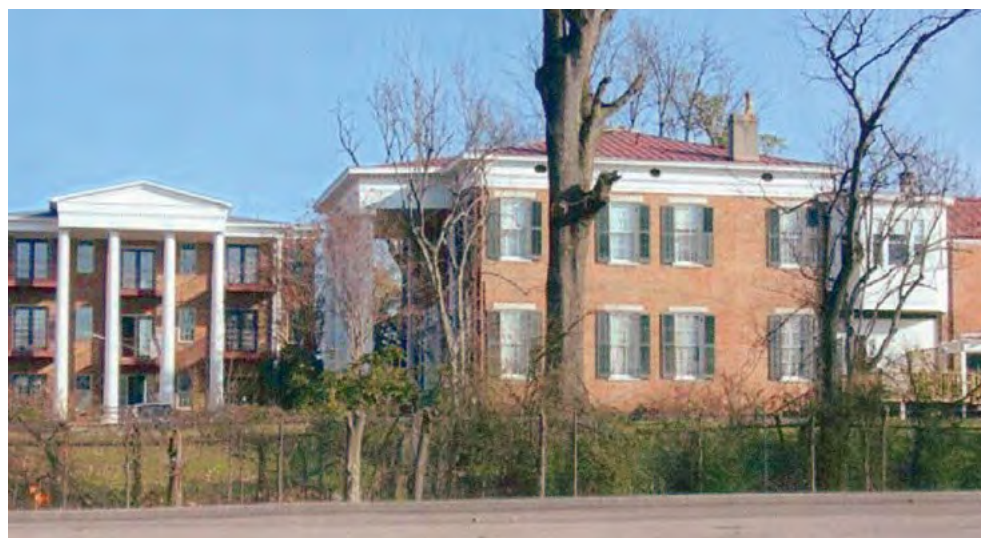
Adding conjectural landscape features to the site (such as period reproduction light fixtures, fences, fountains, or vegetation) that are historically inappropriate, thereby creating an inaccurate appearance of the site.

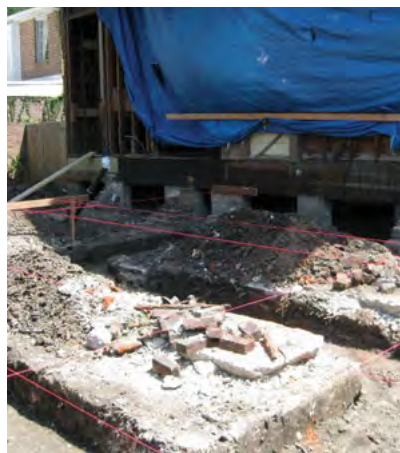
[45] Undertaking a survey to document archeological resources may be considered in some rehabilitation projects when a new exterior addition is planned.

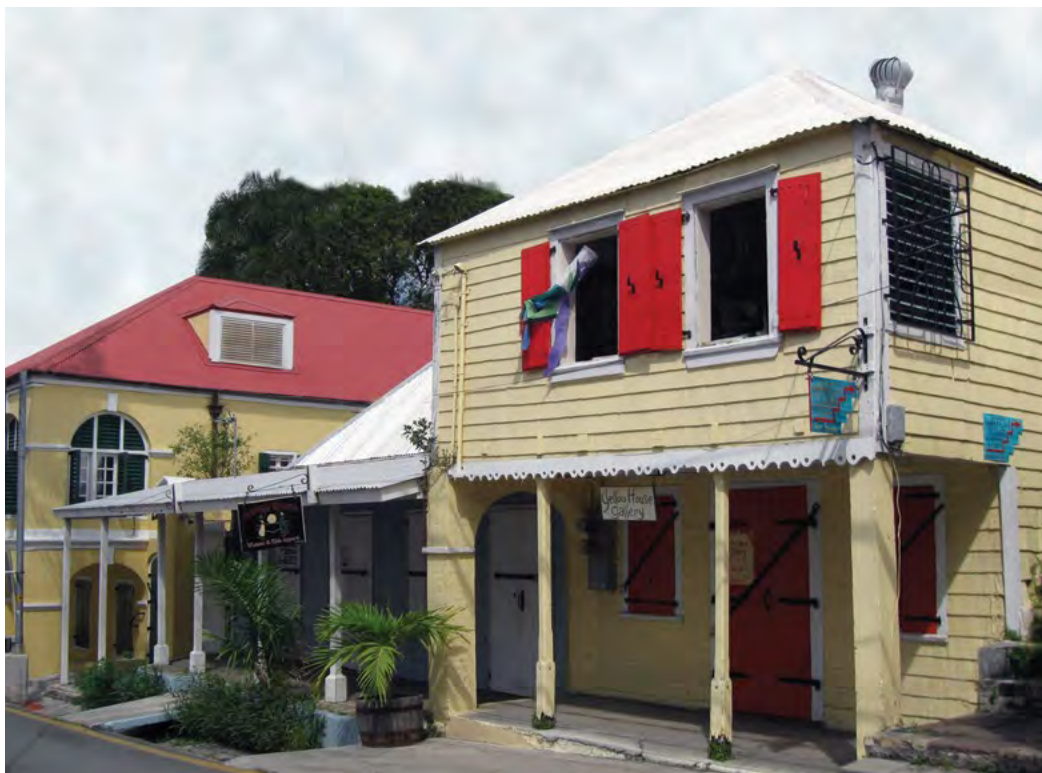
[46] The varied size, shapes, and architectural styles of these historic buildings are unique to this street in Christiansted, St. Croix, USVI, and should be retained in a rehabilitation project.

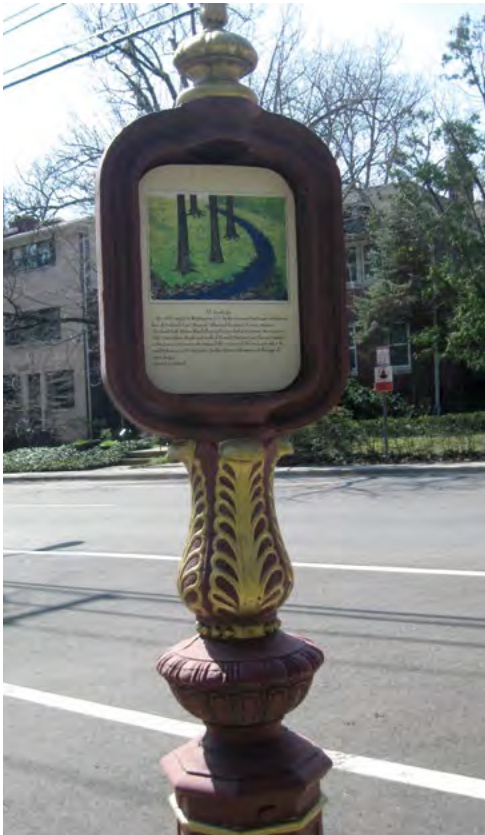
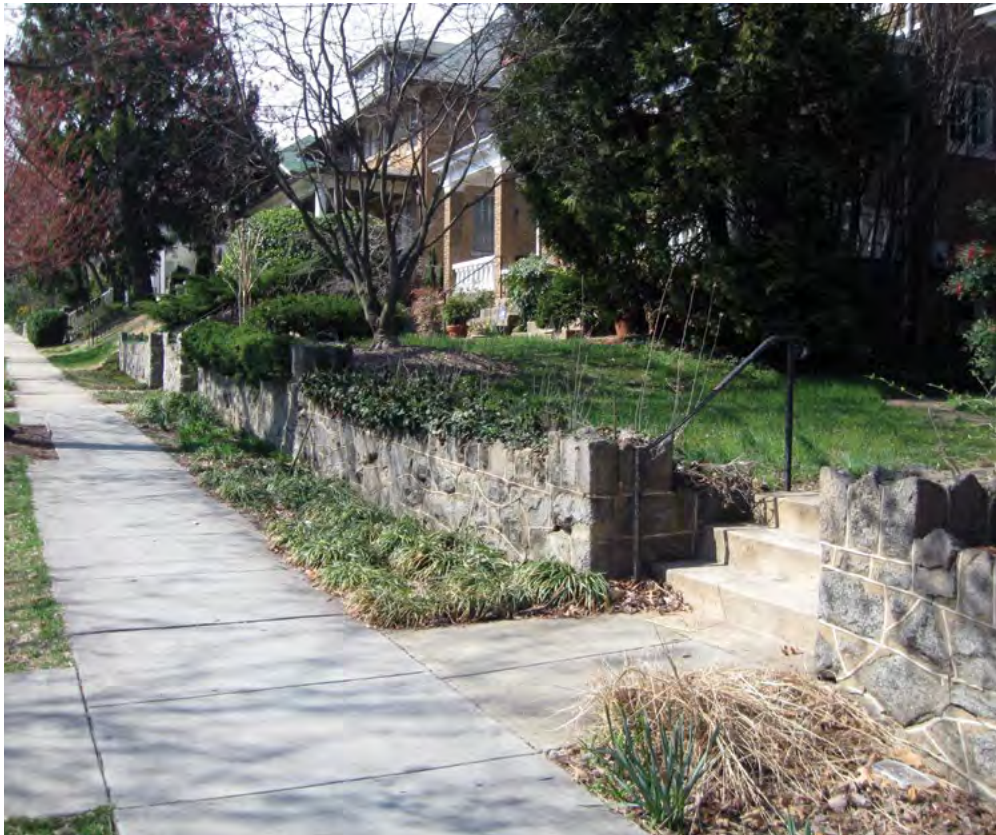
## SETTING (DISTRICT / NEIGHBORHOOD)

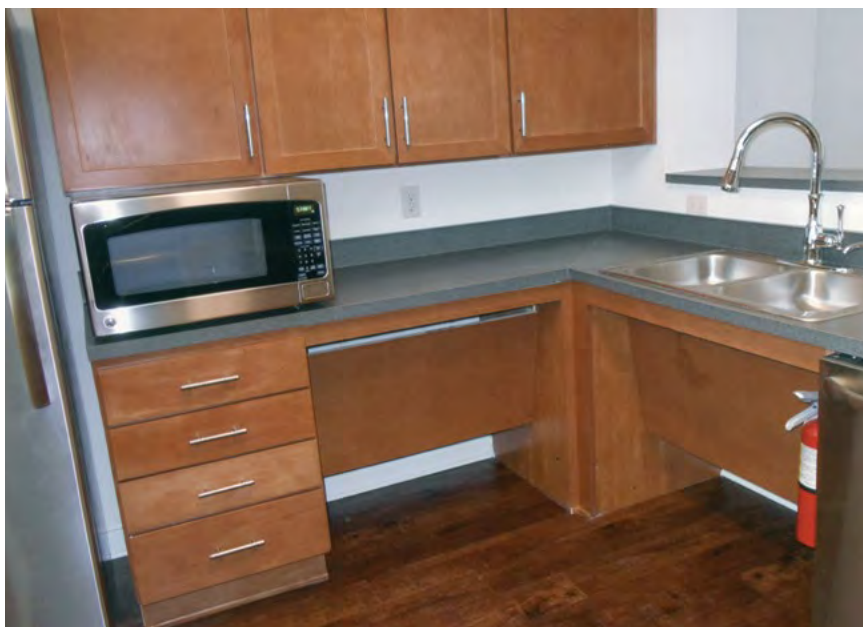
[51] A new interior access ramp with a simple metal railing is compatible with the character of this mid-century-modern building.

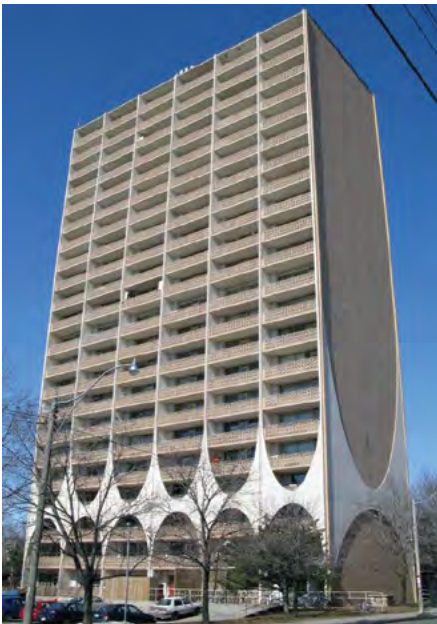
## CODE-REQUIRED WORK

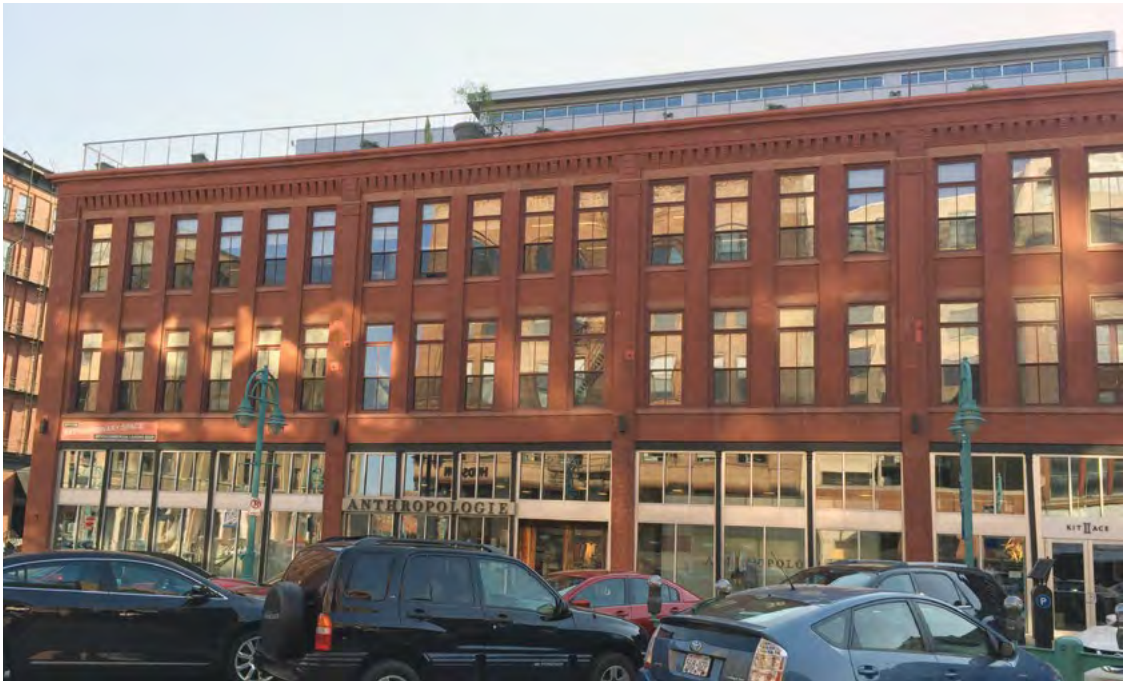
[64] **Not Recommended:**  
It is generally not appropriate to construct a rooftop addition on a low-rise, two- to three-story building such as this, because it negatively affects its historic character.

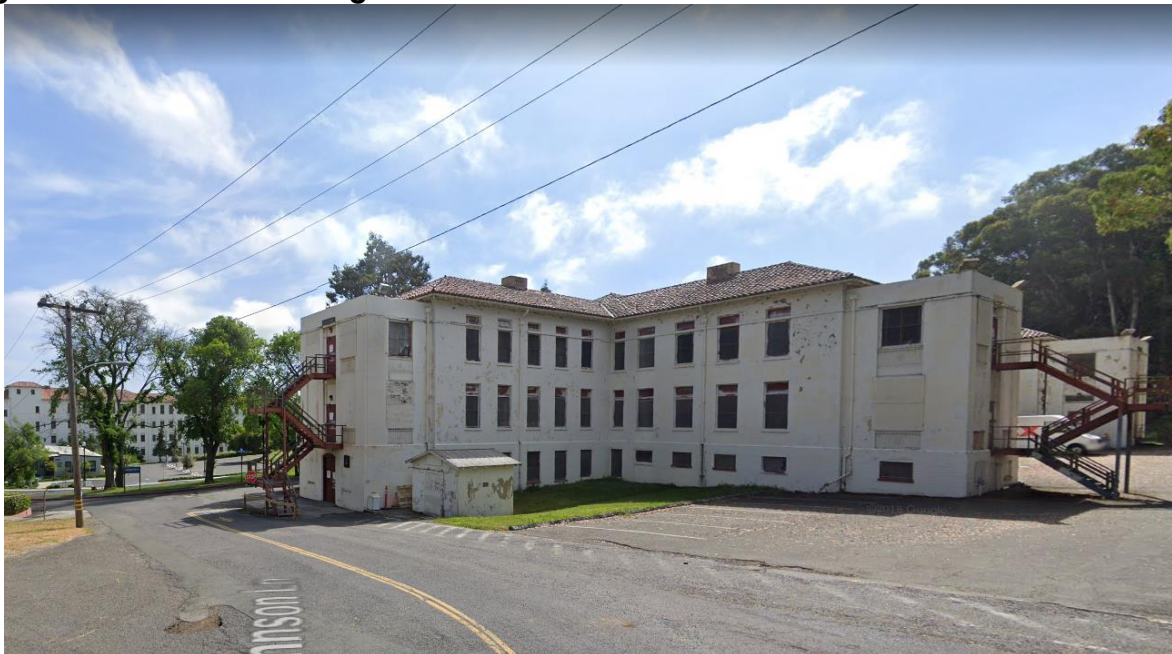
Source: Google Earth, Capture April 2019
